Town of Cutler Bay

Aquatic Facility Condition Assessment

Cutler Ridge Park

Pool and Mechanical Equipment

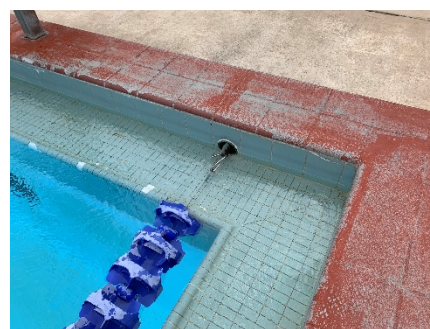
The gutter system includes an infinity level gutter ledge about 12 inches wide that is set with small light blue tiles on the bottom of the gutter and larger pool tiles (Daltile) on the backsplash and below the ledge on the face of the pool wall to a depth of about 8 inches below the water line. At periodic intervals, there are round openings in the back of the gutter that allow pool water to be collected and returned to the equipment yard for treatment. The spacing of the inlets seems to be about every 40 linear feet, which would have been standard in the industry at the time of original construction. The water elevation at the gutter line around the entire pool appears to indicate that the pool is still level.

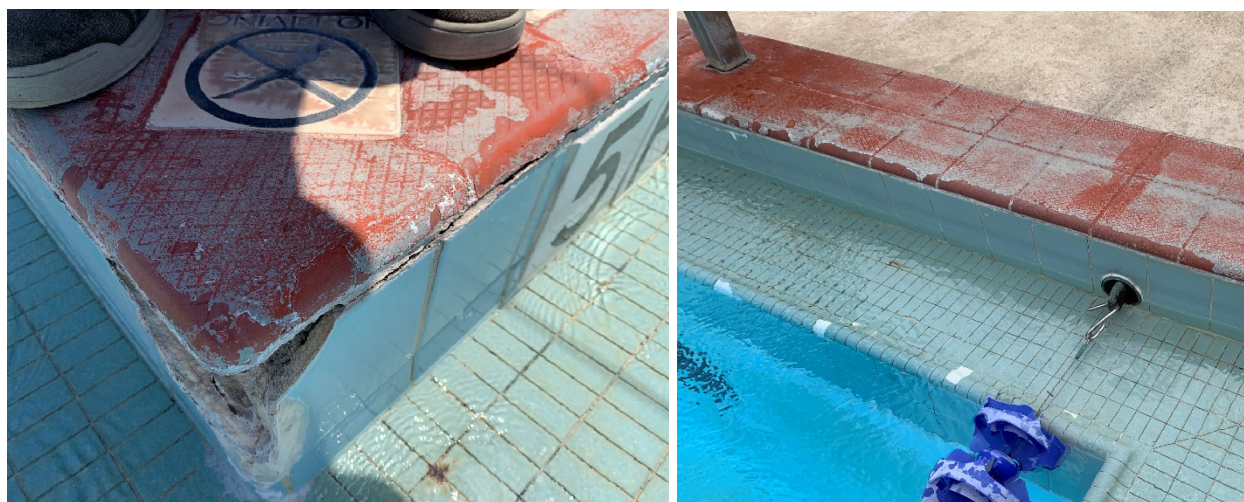
The gutter tiles are in fair condition but there are noticeable repairs and/or missing tiles observed throughout the pool area, most evident near the pool gutters closest to the building, especially in the southeast corner area near the dive platform. We have been informed that then tiles are no longer available and therefore cannot be repaired in kind. To complicate the issue, the current Florida Swimming Pool Code requires that all edges of any in- or underwater ledges (gutters, swim outs, sunledges, steps, etc.) needs to be a contrasting color to the pool and gutter tile which means that the gutter does not conform to current code requirements. We understand that Town staff is in the process of obtaining quotes to perform the necessary repairs.

There are chipped pool tiles along the gutter overflow but in general, those tiles (light blue) are in good condition. These tiles are not readily available and difficult to replace. In addition, the tile edge is supposed to be a contrasting color to the gutter and pool walls. Since the blues are so close together, the gutter edge will need to be replaced even if the pool is repaired, per industry standard.

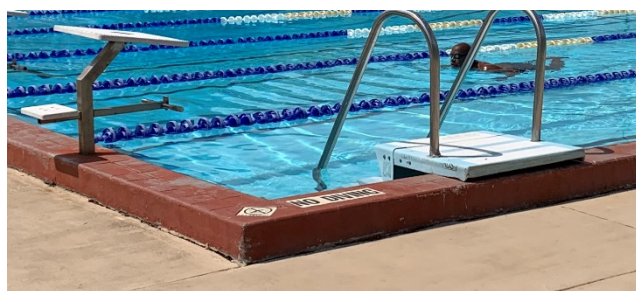
In the northeast corner of the pool, the gutter curb has deteriorated to the point that water from the pool can leak out of the pool through cracks in the back of the gutter. This was observed in our inspection. The expansion joint behind the gutter curb on the pool side is exposed at that location and water can be observed leaking through the gutter and draining down into the soil below the pool deck slab. This may also be occurring at other gutter locations but could not be observed because the expansion joint at other locations still contained a sealant blocking any visual observation below that. Pool staff believes that there are other similar leaks that cannot be located based on the amount of refill water needed to maintain the pool level.

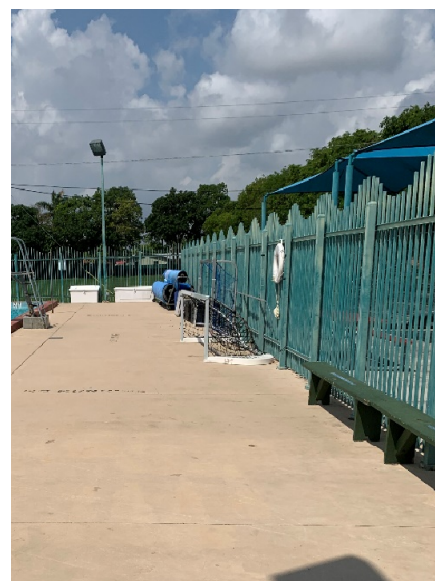
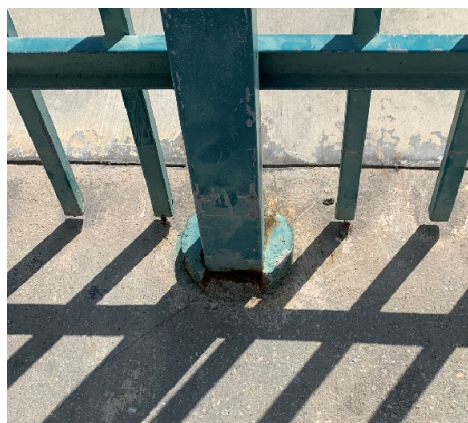
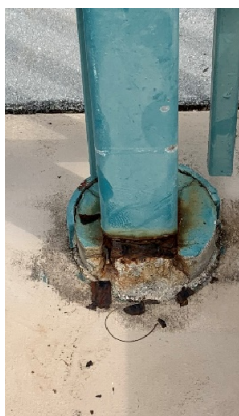
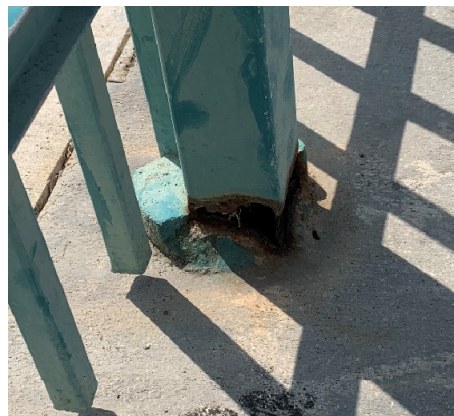
Most noticeable of these items is the fencing which completely surrounds the pool for security and provides enclosure for the equipment yard. The fence is a powder coated steel picket style fence with gates in the northeast corner and between the pool deck and the equipment yard. The fencing has been painted at some time in the past as evidenced by observation of brush strokes and fading noted at many locations. The age of the fence is not known but appears to be in the 20-to-30-year range. There is a considerable amount of corrosion (rust) at numerous locations, especially around the bases of the support poles. In many instances, the corrosion is so severe that openings have been created completely through to the interior of the columns. The base plates and anchor bolts are also highly corroded at many locations. It appears that over 25% of the fencing is exhibiting some corrosion from moderate to severe at this time.

The ancillary features around the pool deck area have also been evaluated. First and foremost is the fencing. As mentioned earlier in the report, it is a steel picket style fence that has been in place for a relatively long time. It is not quite as old as the pool itself but appears to be on the order of at least 20 to 25 years old based on the condition assessment. There is severe corrosion in many of the fence post bases and some are in serious poor condition. In general, the fence was solid to the touch and under normal circumstances, will continue to function for a couple more years with some paint and minor repairs. However, we do not feel that the fence would hold up under severe weather conditions, especially hurricane force winds should any solid object be blown into the fence with high velocity.

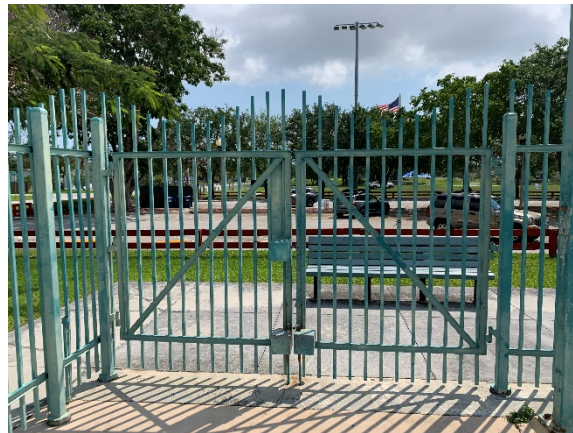
The gates are constructed of the same materials as the fencing and are working as designed and move freely. The gates do show some level of corrosion around the bases of the posts as well as around the hardware on the hinges.

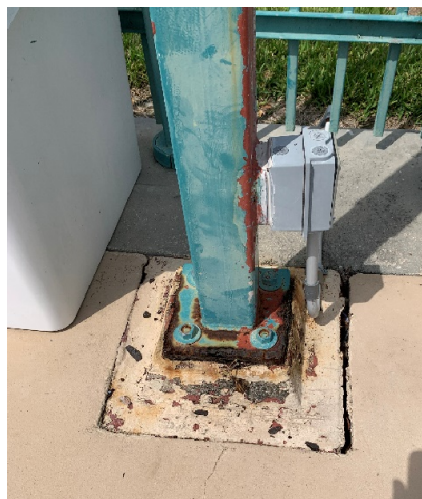
The associated deck light poles are also showing the same level of corrosion as the fencing. Similar in construction to the fencing, the poles were fabricated from steel and many

of the bases, pole bottoms and anchor bolts showed severe corrosion. We have been informed that the lights are working and, in fact, appear to be quite bright. The lighting level shall be discussed further in the evaluation section of this report.

The light poles are somewhat similar in that they are showing a considerable amount of corrosion around the bases and anchor bolts. Based on their condition, they appear to be of about the same age as the fencing.

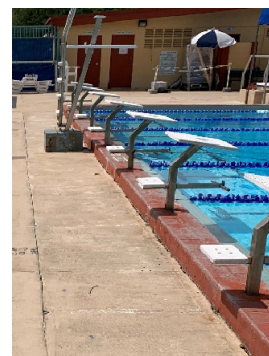
The existing starting blocks on the east side of the pool are embedded in the gutter curb with anchor bolts on each base plate. The bases of the starting platforms show some corrosion and there is some minor cracking around a couple of the bases. We have been informed that the blocks are not used currently for competition purposes, but long term, pool staff would desire to have functional competition pool if the pool can accommodate it. To that end, the backstroke flag poles are not really needed, but currently exist on the deck. There is some cracking in the pool deck around a couple of the inserts, which are potential hazards.

The starting blocks are not currently being used much, if at all. If the Town decides to utilize them, they should consider long term that since the platforms are attached by anchor bolts directly into the top of the gutter curb, With the recommendation that the curb should be replaced, then the platforms would also need to be replaced as well. Removing them and resetting them into a new curb would not work due to the condition of the base plates, which are showing signs of serious corrosion.

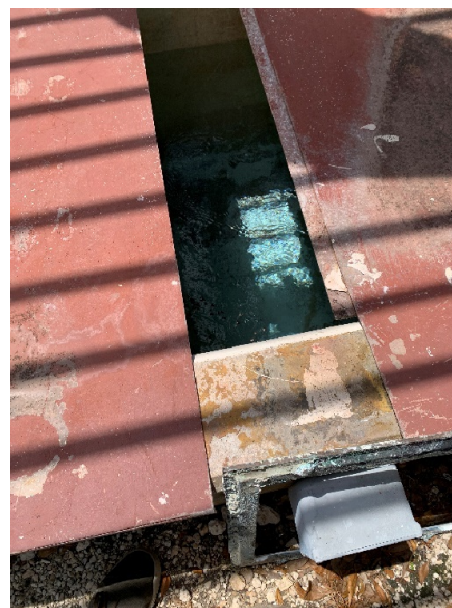
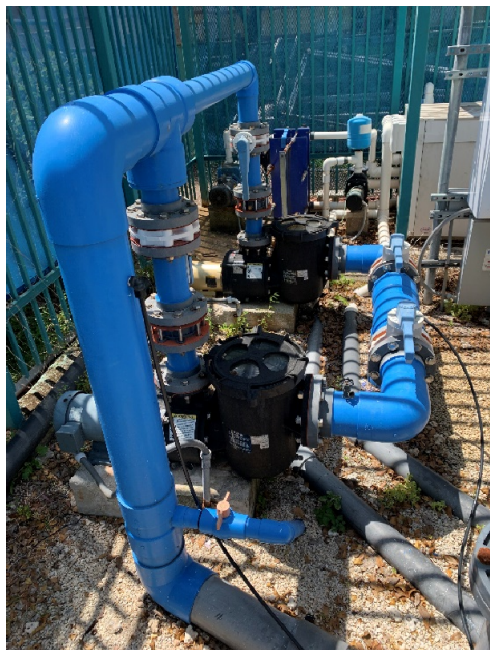
The tank has a painted sheet metal lid in two (2) pieces that slides on and off when maintenance of the tank is required. It covers most of the top but has openings for the piping and some miscellaneous opening at one location. These openings can allow some rainwater to enter the system, but that also occurs in the pool. The concrete tank walls are showing severe signs of distress with spalling occurring on the eastside wall above ground and the corner exhibiting a large spall out of the northeast corner that is

currently exposing all of the reinforcing steel in that area. The steel also exhibits a high degree of corrosion. The tops of the tank walls are also chipped and spalled all around the opening.

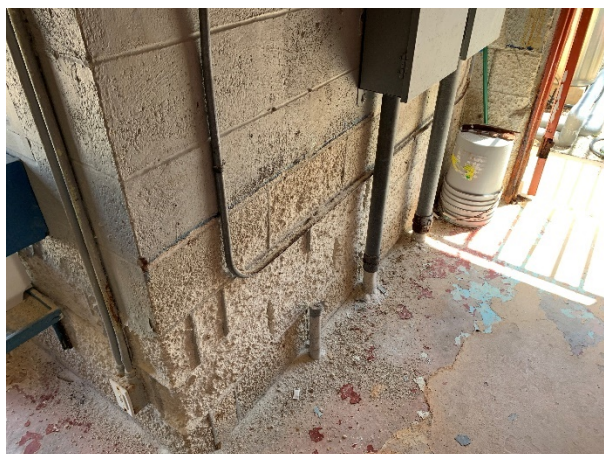
However, the condition of the actual containment room as well as the remainder of the storage room is in very poor condition. The chlorine fumes have eaten the matrix out of the masonry block along all of the lower levels of block both inside and outside the smaller room. The fumes have also started corroding the edges of the metal electrical panels in the room; not to the point where they will cease functioning, but noticeable even at a glance. There is some miscellaneous piping that runs along the ceiling suspended by hangers that we have

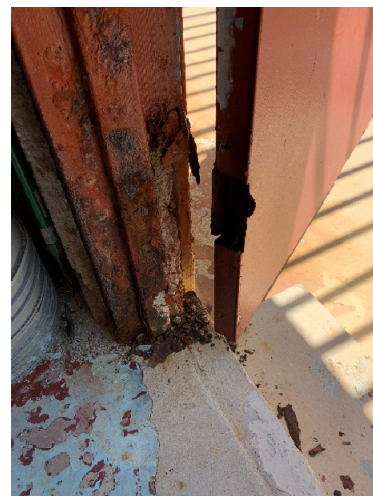
There is a floor drain in the containment/storage room (separate from the chemical containment area) that is corroded to the point of non-usable condition, and we were informed by pool staff that it does not actually work. The larger room surrounding the chlorine containment room is used for storage of dry chemicals for the pool and miscellaneous equipment not in use. Access to the room is by two (2) doors; one on the northside facing the pool, and one

on the eastside facing the equipment yard. The metal doors are all severely corroded, especially the jambs and hinges, which do not function well at this time. Although the wall vents in the storage room are comprised of concrete and in fair to good condition, there is no flow through ventilation to remove fumes and move air. The one metal vent in the containment room is severely corroded and the concrete surrounding it is starting to spall.

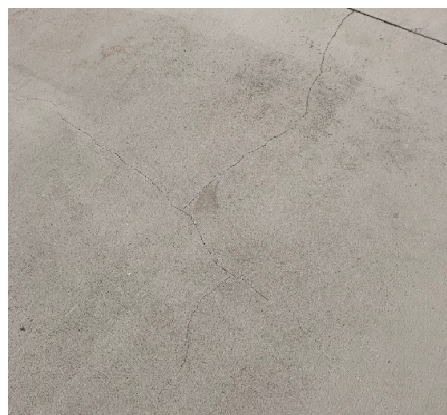
1. **Shrinkage cracks** – these are isolated cracks typically isolated and running from one point to another. Many of these were observed at midspan (between sawcut joints) locations or running from corners or objects embedded in the slab such as equipment inserts or light pole bases. In these cases, those cracks reflect what should have probably had a sawcut joint applied during the original construction.

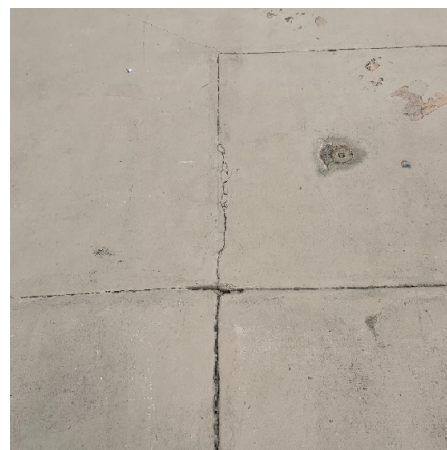
2. **Distress cracks** – these are groups of cracks associated with a common focal point with multiple cracking around an object or location. These were observed near some of the deck features, such as drains, valves, pole inserts, lifeguard stand, etc., as well as the starting platforms. These also were observed at locations of apparent previous deck repair beneath the coating that is now on the deck. The geometry of the cracking is such that it runs in straight geometric lines with 90 degree turns and such that is unusual in normal concrete cracking.

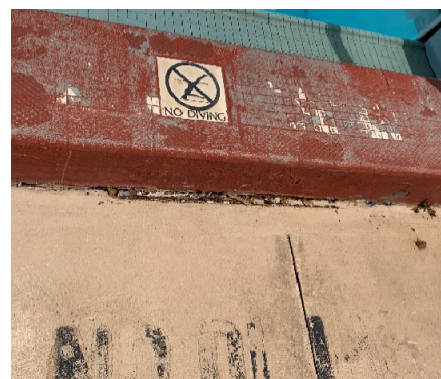
3. **Settlement cracks** – these were observed mainly behind the gutter curb and around the dive platform pedestals and are exemplified by movement of the slab and/or expansion joint with loss of joint sealant and differing height of the gutter curb from the adjacent slab at various locations around the pool.
