Town of Cutler Bay

Aquatic Facility Condition Assessment

Cutler Ridge Park

Pool and Mechanical Equipment

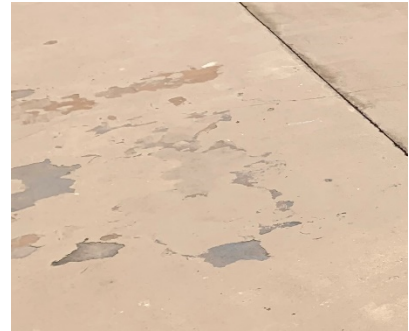
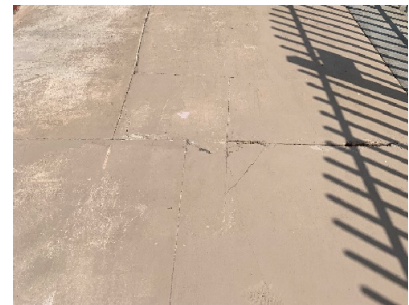
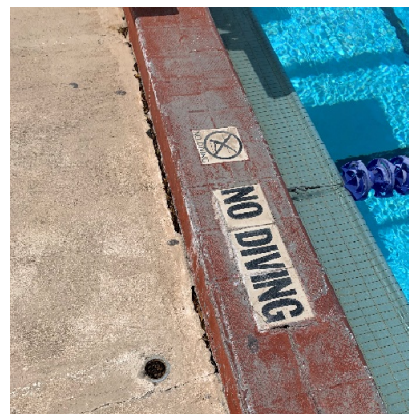
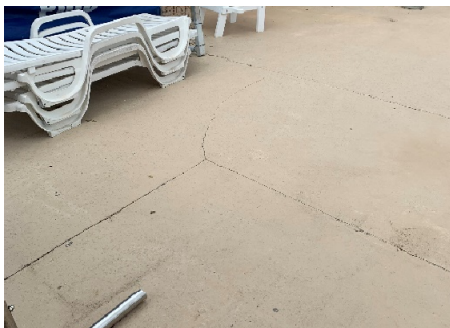
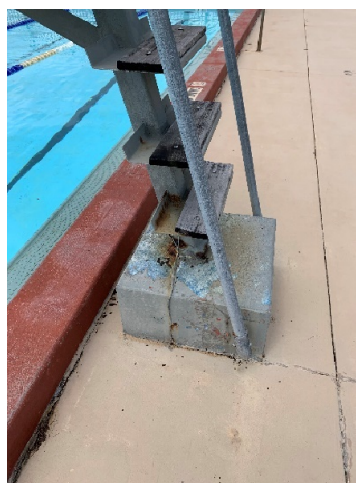
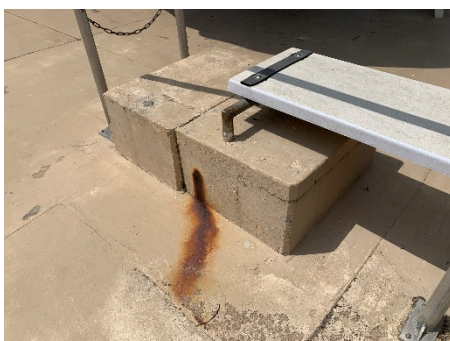
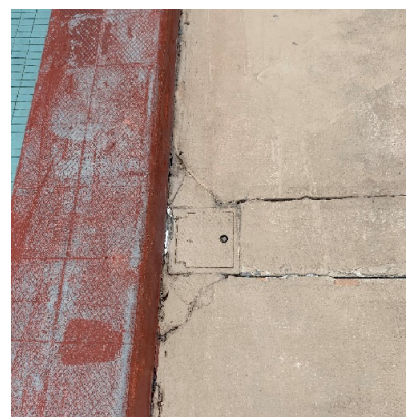
1. Delamination of the deck surface coating at numerous locations throughout the deck.
2. Shrinkage cracks in the pool deck concrete.
3. Settlement and deterioration cracks around the back of the raised pool curb and around some of the drainage structures, deck inserts and old lifeguard stands.
4. Deterioration on the backside of the raised pool gutter curb.
5. Cracking around some of the deck drains.
6. Previous repairs and cracking around the diving board pedestals.
7. Corrosion of the dive platform pedestals and rust from reinforcing steel bleeding through.
8. Exposed copper wire on old lifeguard stands and on back of gutter curb at pool light locations.

It should be noted that the different types of distress that were observed, most notably the cracking in the decks, varied greatly in the severity and extent of the damage. In some locations, the cracks were typical of shrinkage cracks, which were observed at locations where control joints should have been cut. Other cracks appear to be the result of settlement of the deck illustrated by differential elevations on either side of the crack, most notably along areas which appear to have had previous repairs. Additionally, in that same area, the deck has also settled behind the pool curb as much as $\frac{1}{2}$ of an inch below the curb.

The deck drain and valve cover lid (or lack of lid) issues offer a different situation. In some of those areas, the shrinkage cracks around the grates/lids have deteriorated to the point where there is substantial distress and weakening of the concrete slab around the drains. This has allowed the lids to move and become somewhat dislodged and, in some instances, extend above the deck to the point where they can become a potential hazard to bare feet.

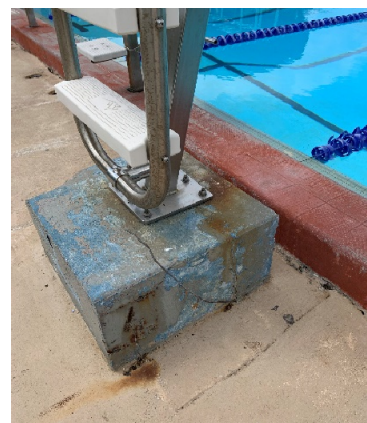
compensate, pool staff has incorporated moveable stairs located at two (2) locations in the pool. These are manufactured from fiberglass and resin with metal handrails and are currently functional for use. However, the stairs do show some damage with cracking along the sides. The old ladders have been discarded but the inserts around the perimeter of the pool still exist in the deck. Many of these indicate distress in the concrete around the inserts and are rather rough to the touch with bare feet. The lifeguard stand pedestals are permanent type with concrete bases that still exist around the pool but are not in use at this time with the actual seats having been removed from the pedestal and frame. In lieu of those, pool staff utilizes a movable stand fabricated from recycled plastic lumber which is resistant to corrosion and deterioration. There is also a newly installed "Sunbrella" between the pool, and the building that is evidenced by a cut out in the pool deck for the footing.

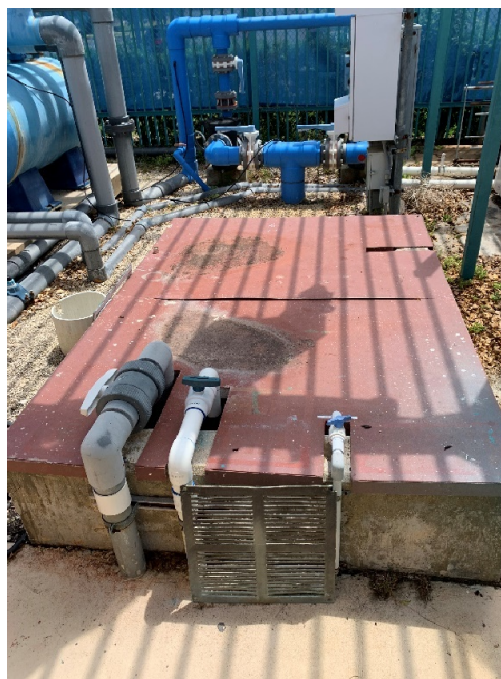
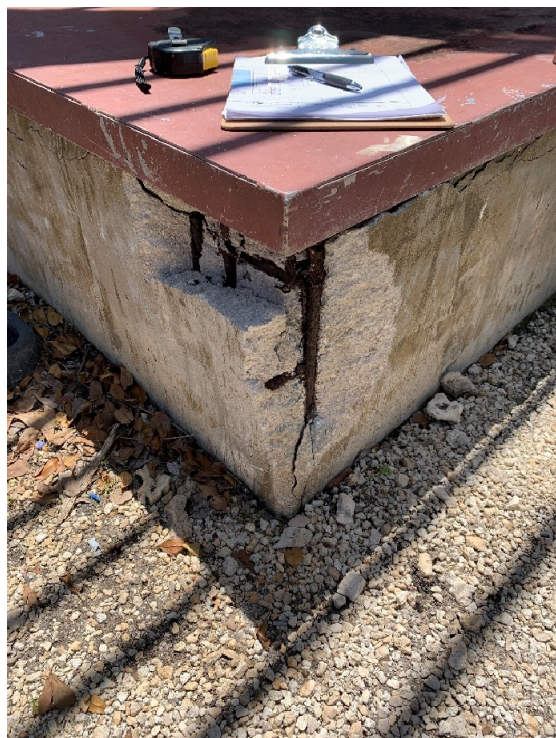
The in-ground collector tank is of unknown age but appears to be original which dates it over 50 years old. The concrete tank has a volume of 160 CF (1200 Gallons) and the top is about 16 inches above ground with the rest set below ground, about 3.5 feet down. The collector tank has two (2) separate line feeds from the pool; one from the main drain and one from the gutter system. It is assumed that each has their own piping system from the pool to the tank. Additionally, there is an effluent suction line to the two pool pumps. There are also two (2) infill lines feeding the tank from the top; one small $\frac{3}{4}$ inch diameter line set with a manual control valve and another larger 2-inch set with a separate manual valve for emergency large volume water needs. There is a larger 3-inch line with a manual valve that can be used for flushing the system, but we have been informed by pool staff that it is not used.

The tank has a painted sheet metal lid in two (2) pieces that slides on and off when maintenance of the tank is required. It covers most of the top but has openings for the piping and some miscellaneous opening at one location. These openings can allow some rainwater to enter the system, but that also occurs in the pool. The concrete tank walls are showing severe signs of distress with spalling occurring on the eastside wall above ground and the corner exhibiting a large spall out of the northeast corner that is

currently exposing all of the reinforcing steel in that area. The steel also exhibits a high degree of corrosion. The tops of the tank walls are also chipped and spalled all around the opening.

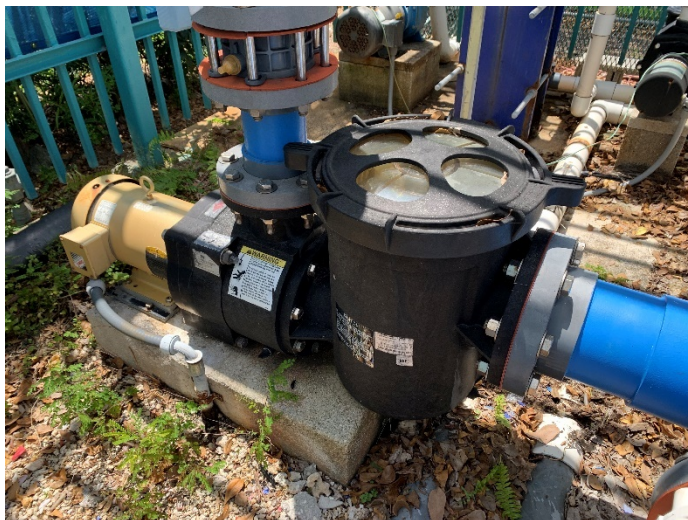
The two (2) pool pumps are 7.5 HP pumps set in parallel that work simultaneously to move the pool water through the system. The pumps are Baldor Reliance Model JMM3616T pool pumps; each with an NSF Pentair strainer basket and independent motor control units (MCC). The size of the pumps appears to be at the lower end of suitable for the volume of water in the pool (130,500 gallons) for a pool load of 100 bathers, and the flow rate of 501 gpm. However, with somewhat lower operating pressures and flow rates than desired (but still acceptable) as noted in our inspection, the pump sizes may just be on the lower limit of being too small. The two (2) pumps are of differing ages as evidenced by the different colors and conditions. We have been informed by pool staff that one was replaced in 2016 and the other repaired in 2020. There is some

corrosion on the housing of the pumps with the north pump looking a little older than the south pump, but both are in fair condition from the outside. The pumps were operating at the time of inspection and there was no indication from the sound of operation that they are currently or imminently running with any difficulty. Most of the piping associated with the pumps appears to be relatively new and suggests that the piping was replaced the last time that at least one of the pumps were replaced.

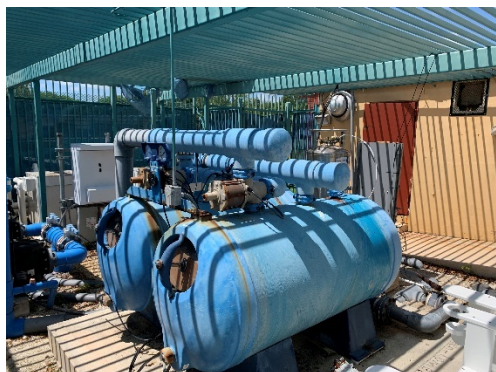
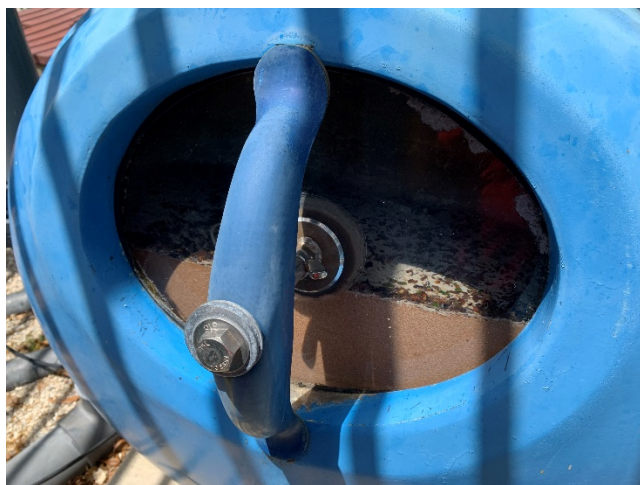
near the viewing panels. All of the filtration piping is above ground and contains valves for manual operation. The valve and controls are placed on a metal bracket that shows a considerable amount of corrosion. Similarly, the top mounted bleeder valves have a lot of corrosion as well around the connection to the tanks and they appear to have had their hardware recently switched out since the bolts et al are shiny metal at this time.

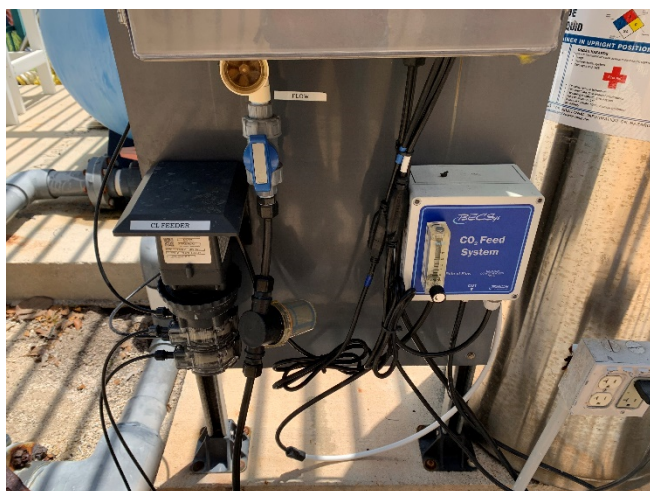
There are chemical feed systems for chlorine and CO2 which are located immediately in front of the sand filters so as to have access to the return piping to the pool. As the piping exits the filters, they extend down to the yard surface level but stay on top of the ground and provide the location for the chemical feed piping. The chlorine controls are mounted on a panel in front of the filters and feed chlorine from tanks that are located in the adjacent equipment room in the building. The feeds come in small diameter flexible tubing that come in overhead from the building and then feed down into then controller and then to the return piping.

Although functioning adequately, the system is dated, and new systems are available. It would also be advantageous to have the chemical feed tubing more protected than it is. The CO₂ is stored in a tank situated on the slab next to the chlorine controller. The tank is fed remotely from an overhead piping system that is accessed outside of the fencing for safety and convenience for the delivery truck/tank. Both chlorine and CO₂ are injected into the above ground piping right before it goes below ground. There are manual valves on either side of the feeds so that the systems can be worked on or replaced without cutting the piping. The CO₂ system appears to be relatively new and in good working order.

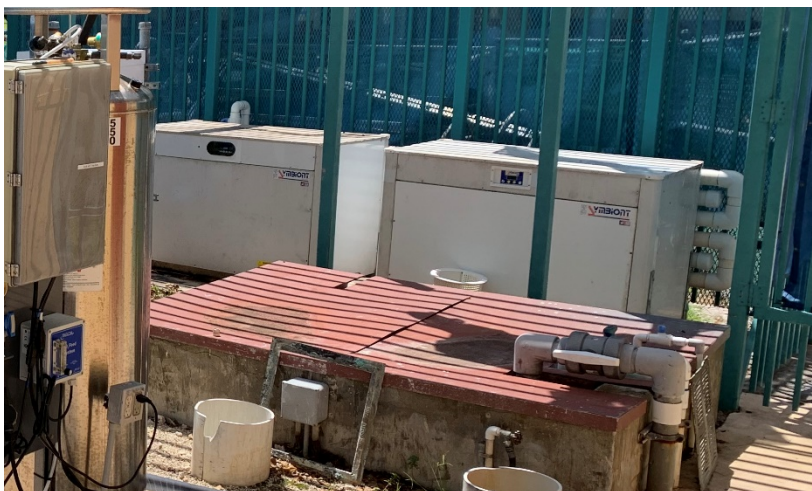
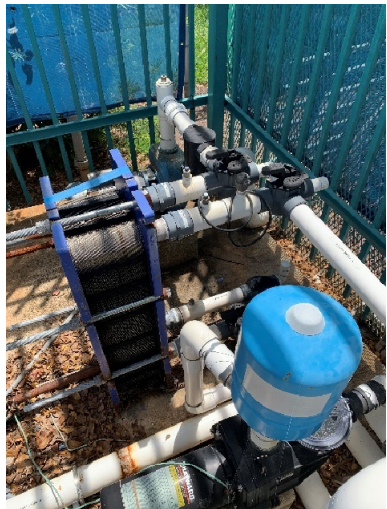
There are two (2) "Symbiont" geothermal heaters on the southside of the equipment yard. They are set lengthwise along the southside fence, and the pumps, wells and controls are set to the east of the units. The heaters appear to be in good working order and have had recent maintenance by the vendor's work forces. But we have been informed by pool staff that they are no longer operational, even with the recent replacement of parts and such. The original date of installation for the two (2) units was in 2010 and subsequent repairs and maintenance indicates that the loop and booster pumps were replaced in 2019. Additionally, one of the display panels was replaced in 2020.

away from the heater and intake well that there is no underground draw from the one well to the other. There was little visual evidence of severe corrosion or damage to the pumps, valves, piping or heater units with some small areas of rust showing at isolated locations. However, as mentioned herein, the units are not

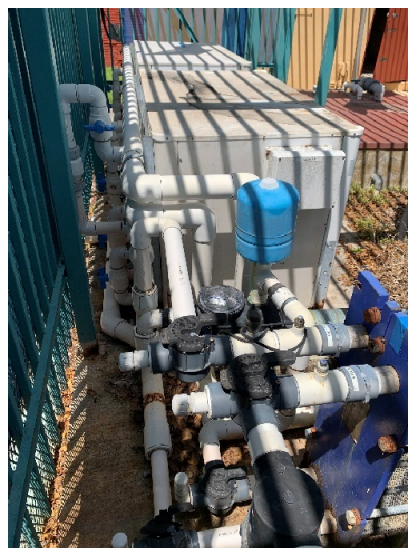
operating at this time. It is assumed that since the pumps are only a few years old, that at least the associated piping and hardware was replaced at the same time.

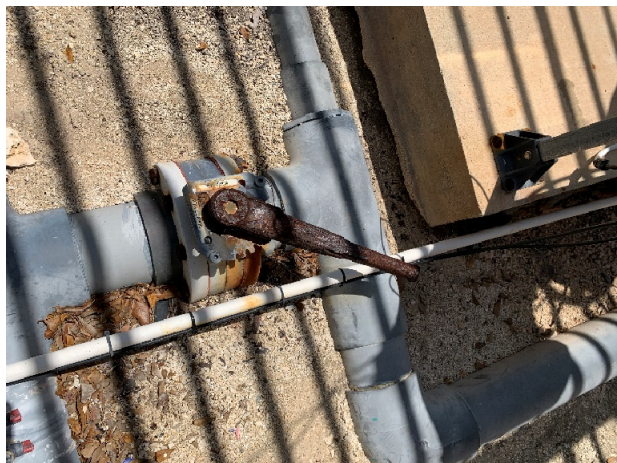
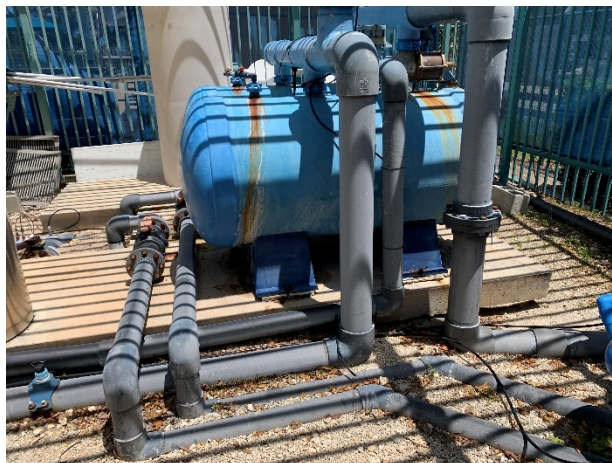
In general, most of the piping in the equipment yard is in good condition. But many of the valves, especially the older metal valves, show a good deal of corrosion, especially the main valve for the return line. The piping is not entirely identified by tag or color as is most typical in newer pool facilities, except the piping associated with the sand filters. However, the fact that most of the piping has been painted or is colored protects the PVC from UV radiation which breaks down the material. The flow meter attached to the piping in front of the chemical feed systems is placed in a traffic area and looks like it has been replaced recently, but pool staff could not divulge when that would have occurred.

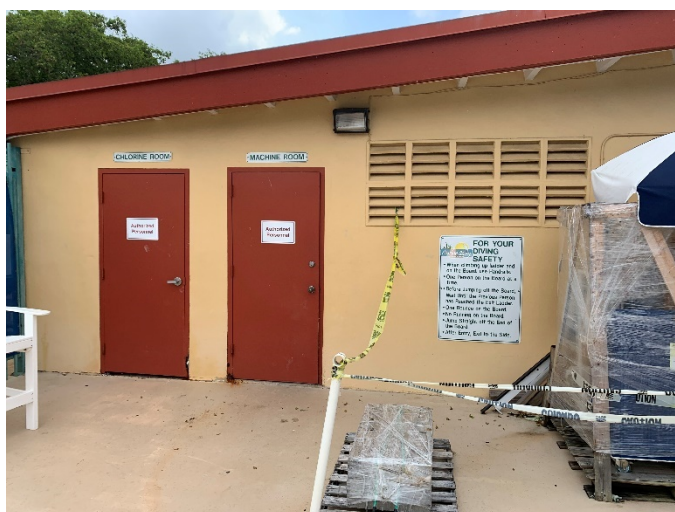
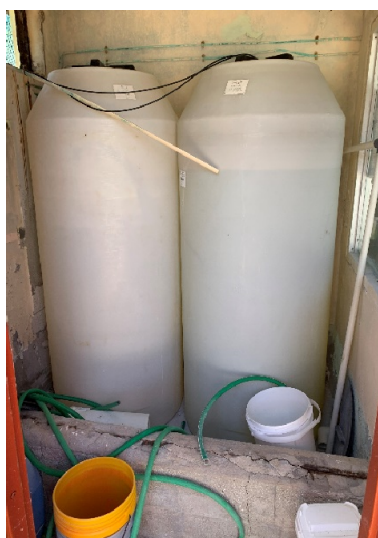
We also inspected the adjacent containment and storage rooms at the end of the building that houses the chlorine tanks, electrical panels and some of the piping. Although the building in general was not in the scope of this assessment, we felt that it has bearing on the overall impact to the pool. There is a small 7' by 7' containment room inside the building that houses two (2) liquid chlorine tanks. That room sits within a larger storage room that surrounds the containment room. There is a separate door accessing the containment room on the northside of the building facing the pool.

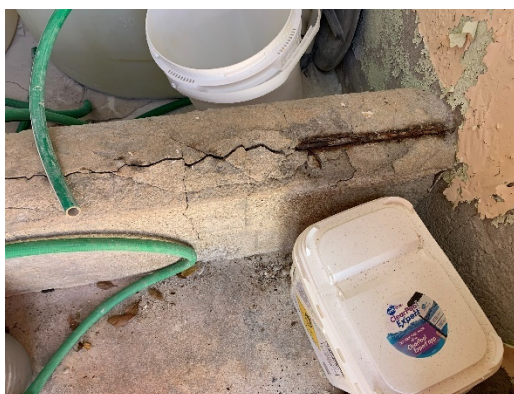
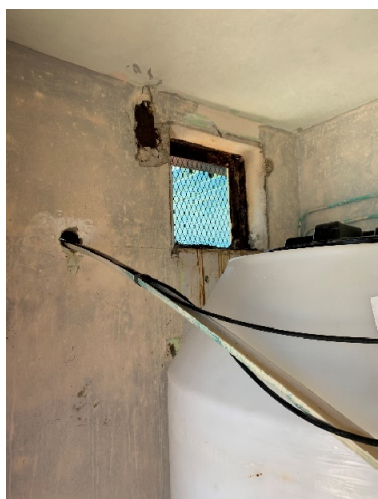
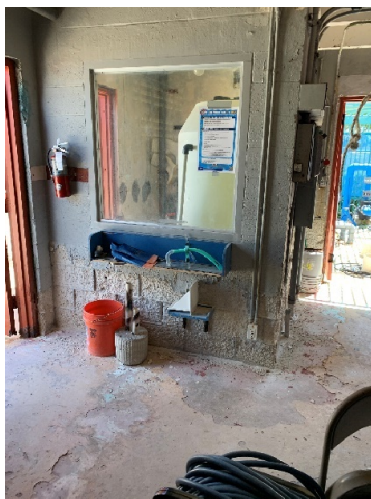
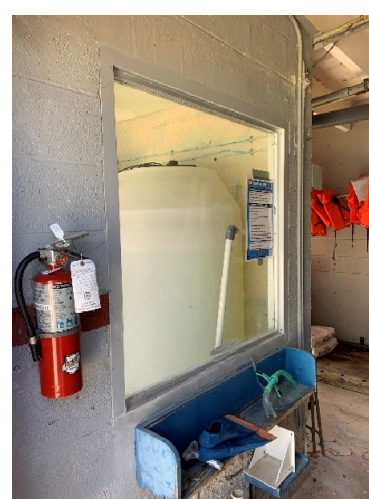
The containment room is constructed of masonry block, as is the entire pool building, and has a small containment curb inside the door to contain any chemical spills. The tanks are plastic and in good condition. The tubing that takes the liquid chlorine to the controller outside runs up above the tanks and out through the side wall to the equipment yard and those appear to also be in good condition and working as intended.

However, the condition of the actual containment room as well as the remainder of the storage room is in very poor condition. The chlorine fumes have eaten the matrix out of the masonry block along all of the lower levels of block both inside and outside the smaller room. The fumes have also started corroding the edges of the metal electrical panels in the room; not to the point where they will cease functioning, but noticeable even at a glance. There is some miscellaneous piping that runs along the ceiling suspended by hangers that we have

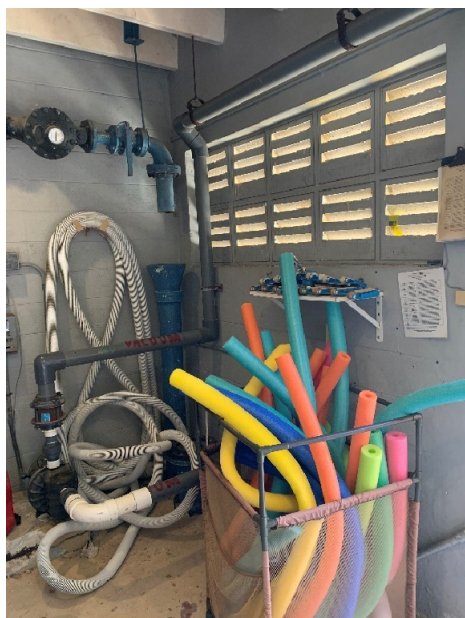
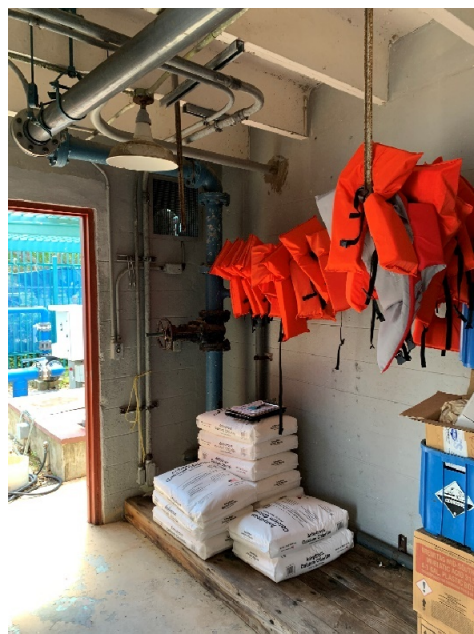
but we again have been told by pool staff that the backwash is separate from that. The metal piping, fittings, especially around the flange connections, and supports are showing signs of corrosion as well. There is a

separate vacuum piping system with pump in the room that is constructed of PVC piping which appears to be in good condition, although the pump itself appears to be an older model.

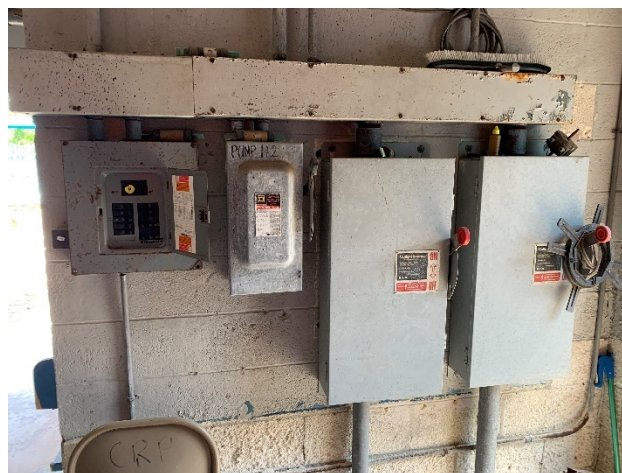
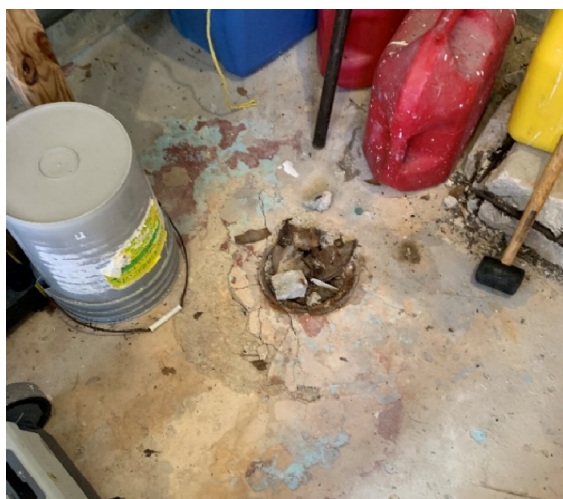
The electrical panels consist of two (2) main power panels for the entire building, one sub panel for the pool and the breaker panel for the pool equipment. Conduit runs up through the floor to feed the mains and from there, conduit runs up to the ceiling and to the west to feed the remainder of the building. It should be noted that many of the conduit and piping runs that extend through the walls are not sealed to prevent weather or small animals from accessing the interior of the room.
